TCS™-Titanium Hardbanding Completion Tubing

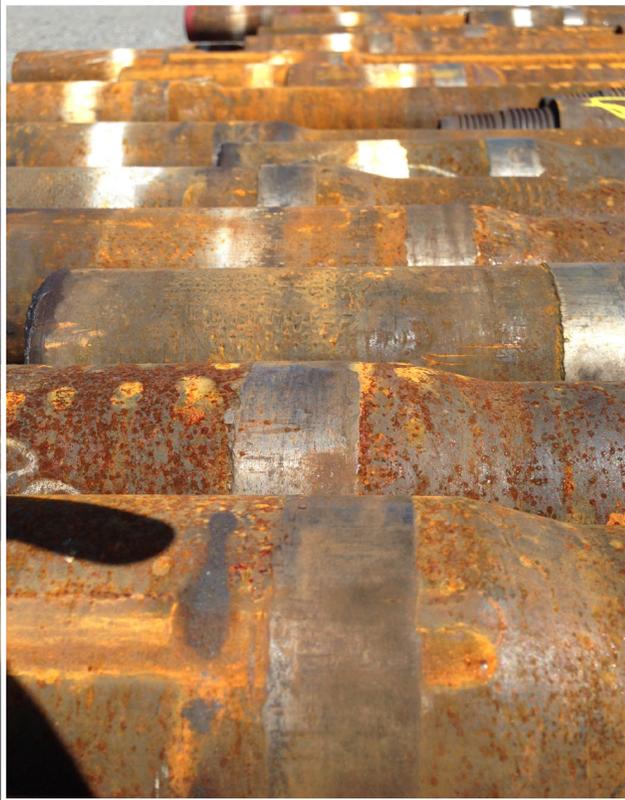
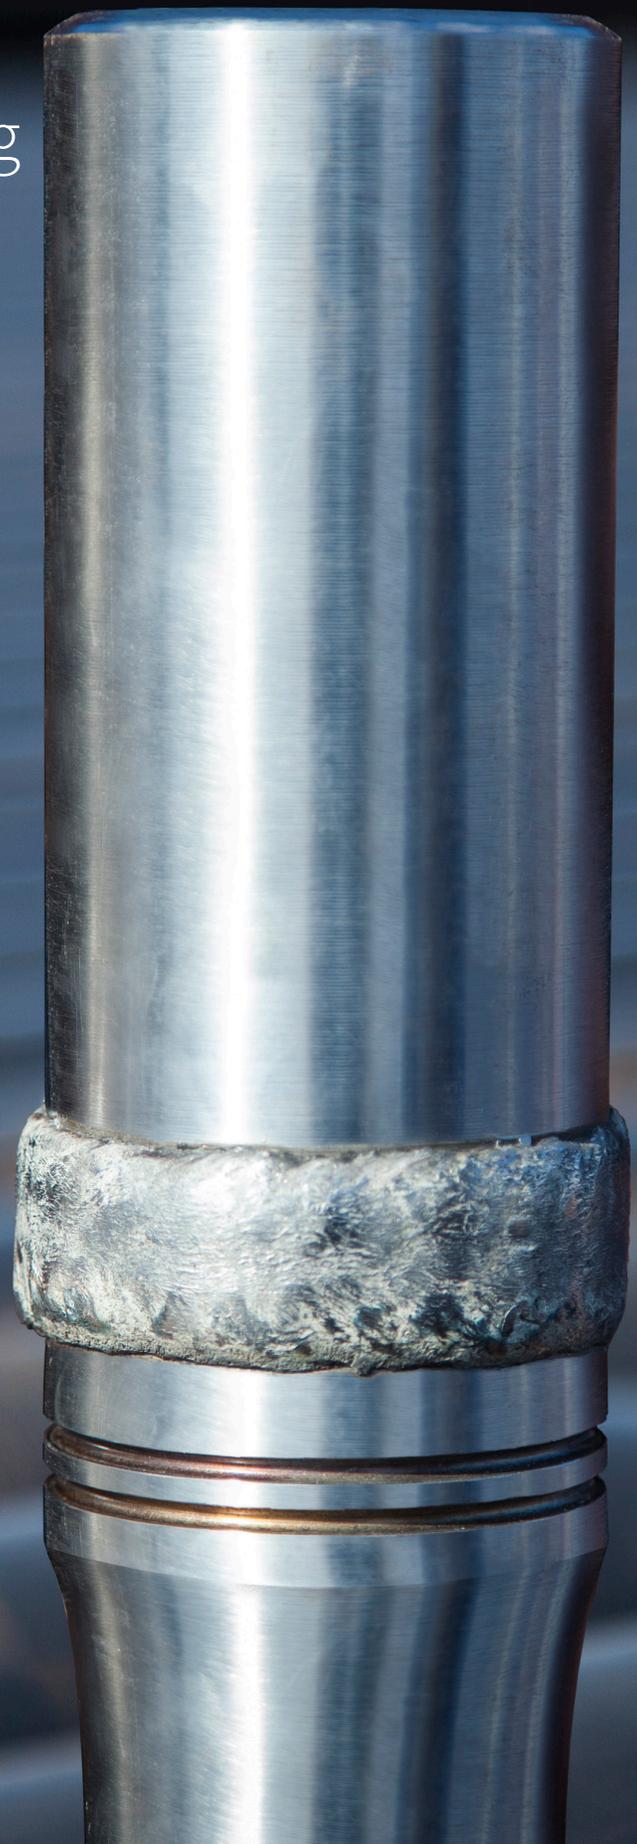
A major operator has increased the life cycle to 70+ completions by utilizing extended upsets with TCS-Titanium applied to both box and pin upsets, along with premium TK™ internal coating. The photo below represents one of these strings being inspected after 69 drill-outs. The hardbanding and internal coating is evaluated upon each inspection. The hardbanding on this string has been reapplied twice.
