Professional and Reliable Installation Services Result in Repeat Business

Sense of urgency, expertise, and communication rectify manufacturing issues in Iowa.

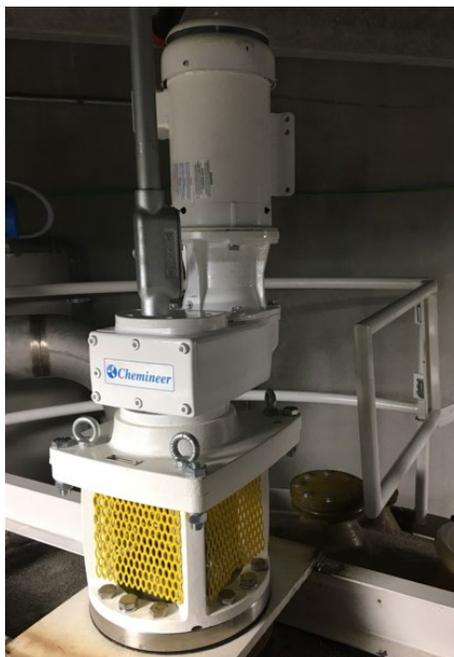
12MR Chemineer complete installation.

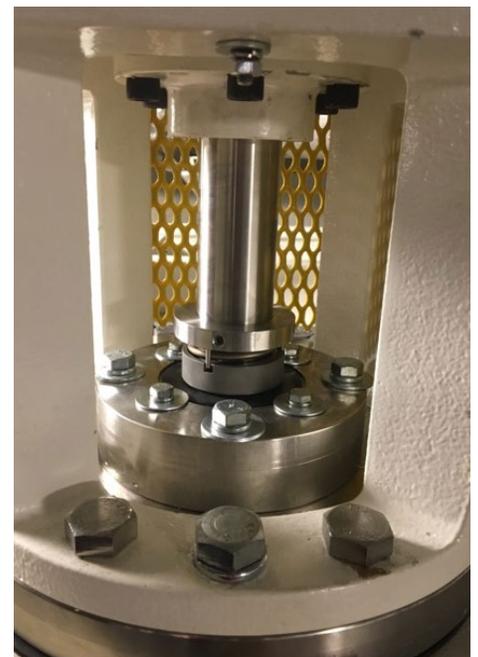
12MR seal aligned and set to proper spring load.
