Service Master II® Well Servicing Valve

Mission Service Master II Valves are the industry standard for pumping well fracturing media such as sand and man-made resin-coated sand proppants. The Service Master II's engineered toughness and integrity gives unparalleled performance in the most punishing conditions such as pumping high-strength ceramic proppants or sintered bauxite at pressures above 15,000 PSI.

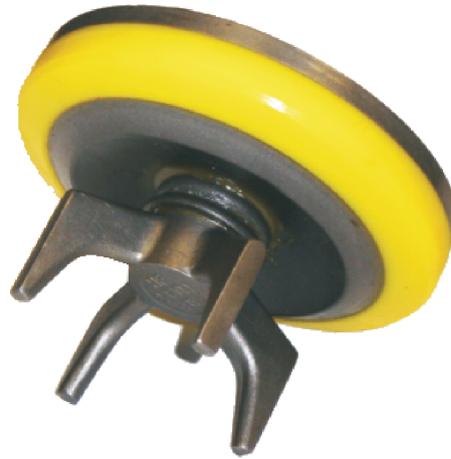
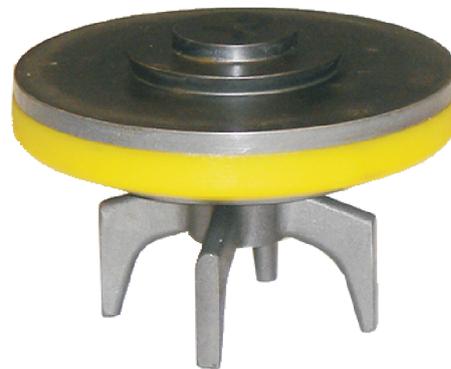
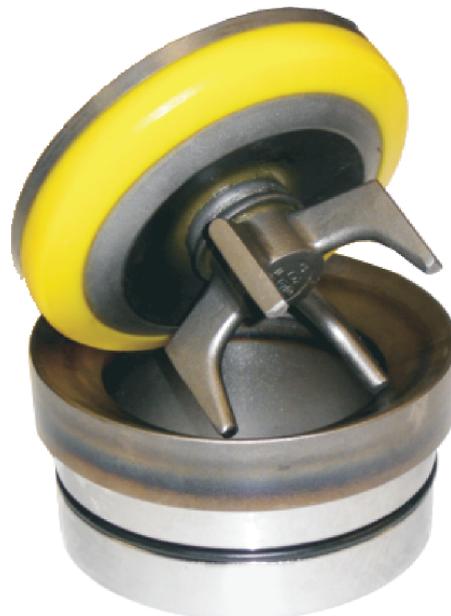
Service Master II® Well Servicing Valve

- Precision machined components for a close tolerance fit
- Heat treated forged alloy steel valve body and valve seat for extended service life
- One-piece, tapered leg guide design allows greater flow area and reduced abrasion
- Available bonded version for extreme service
- Multiple elastomers available to custom fit specific applications
